## Hazardous leakage

The BP Chemicals site in Hull had for a long time suffered problems of leakage from its existing Girdlestone pumps. Although the exotic alloy pumps were reliable, the aqueous organic solution that was pumped at 150°C was very aggressive and tended to leak at the suction cover joint after a period of operation. As well as being a potential hazard this caused unplanned downtime for maintenance

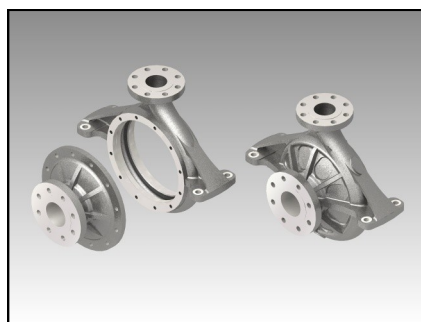
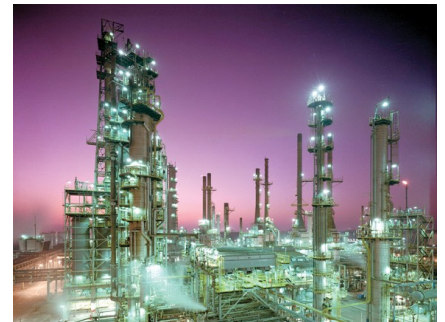
Amarinth proposed a single integrated component consisting of the volute and the suction cover. This was designed to be dimensionally interchangeable with the original components so that no modifications were needed to the pump or the pipework. This new component was up-rated from 16 bar to 20 bar in order to match the rating of the flange and was radiographed and dye penetrant tested.

Since fitting the new component there have been no further problems. BP has benefited from a re-engineered component that actually costs less than the equivalent pair of OEM parts, has reduced unplanned maintenance and prevented any further unforeseen leakages. The life of its expensive exotic alloy pump has been significantly extended.
